**AFTERCARE GUIDE  
&  
FREQUENTLY  
ASKED QUESTIONS**

**Timber Garden Buildings Ltd  
Chesterton Road, Eastwood Trading Estate,  
Rotherham, S65 1SU  
Telephone: 01709 820004**

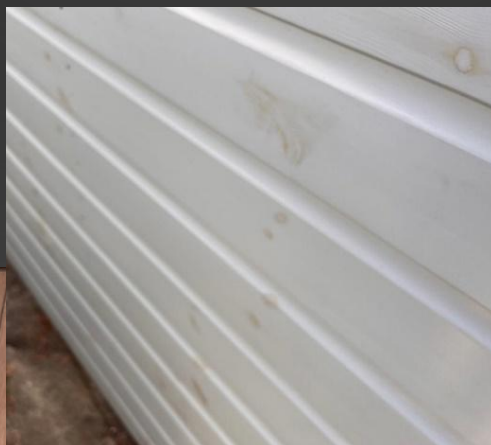
(Please see image of typical potential penetration of sticky sap)

In addition to soluble extractives, the cell structures of wood contain groups of chemicals, often referred to as exudates. In softwoods, the principal exudate is referred to as resin and can show itself in coating discolouration, viscous liquid, or crystalline solids on the surface of the timber or coating, or combination of both. Resin staining and exudation is commonly seen at knot margins but is also found in resin ducts and sometimes on latewood bands. Timber species, age, growth conditions, season of harvest, the ratio of sapwood to heartwood and the number of live knots all have an influence. The staining associated with resin is chemically different from the tannin stains of hardwoods and many hardwoods isolating primers offer relatively ineffective protection against resin staining. Resin exudation is usually initiated by a combination of heat and moisture, which changes the resin from a solid to a liquid and in severe cases a gas. Specific weather conditions can trigger the problem and discolouration will occur most rapidly on warmer southern elevations when humidity levels are high. Darker coating colours, which absorb more energy, may initially disguise staining, but can accelerate resin migration leading to blistering and adhesion failure. The problem is often seen around knots, where the preservation fluid will partly dissolve resin concentrates, bringing them to the timber surface, producing severe staining and blistering even when knotting solution is used. There is no fool proof solution to the problem of resin exudation.

STICKY SAP AND RESIN CAN EASILY PENETRATE THROUGH PRIMERS AND PAINTS. TO REDUCE THE RISK OF THIS WE USE HIGH QUALITY PRIMER AND A TOPCOAT OF WOOD PAINT.
